ARTI Home Inspections, LLC
Property Inspection Report

1000 Anywhere Rd., Anywhere PA, 19000
Inspection prepared for: John Doe
Inspection Date: 4/15/2010 Time: 10am - 2:30pm
Weather: Sunny, 70 degrees

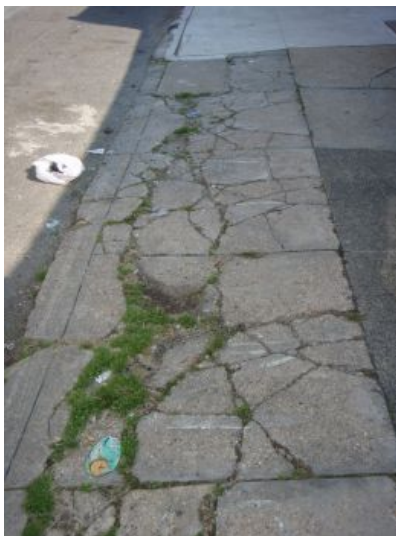
- Major crack cracking and settlement noted on driveway. Sections of the driveway have created trip hazards. A licensed mason is recommended to evaluate and replace damaged driveway.

Major Damage Noted at the Driveway

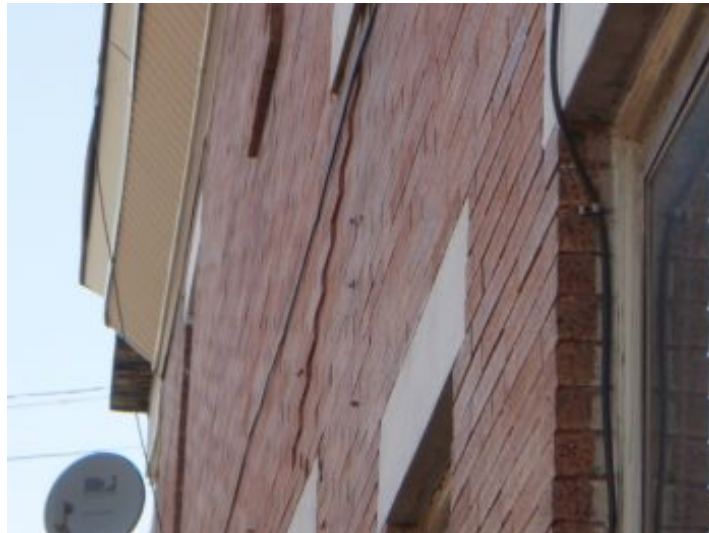
- The mortar shows signs of moderate deterioration throughout the building, especially on the east side of the house. A licensed mason is recommended to fully evaluate exterior walls, replace any damaged brick and repoint all deteriorating areas.
- The brick shows signs of movement and appears to be bulging above the west facing door above the door to the 1st floor rear unit. A licensed mason is recommended to fully evaluate and repair bulging brick.

Bulging Brick Above 1st Floor Rear Entrance

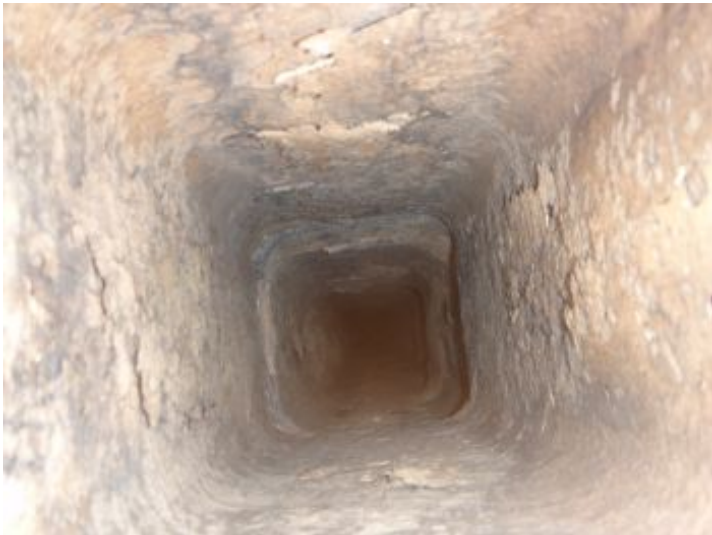
- Raincap missing. A licensed contractor is recommended to add a proper raincap to the chimney flue.
- The chimney crown is cracked and deteriorating. A licensed mason is recommended to repair the crown to prevent future moisture problems.
- **The flue liner is deteriorating and there are 6 gas burning appliances that vent to the same flue. A licensed chimney sweep is recommended to fully evaluate chimney, add a new chimney liner and repair the damaged chimney crown.**

Deteriorating Chimney Liner

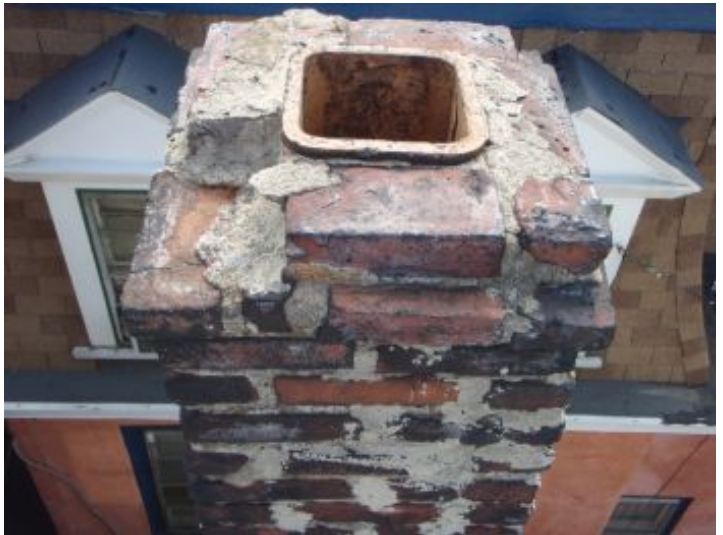
Chimney Crown is Deteriorating

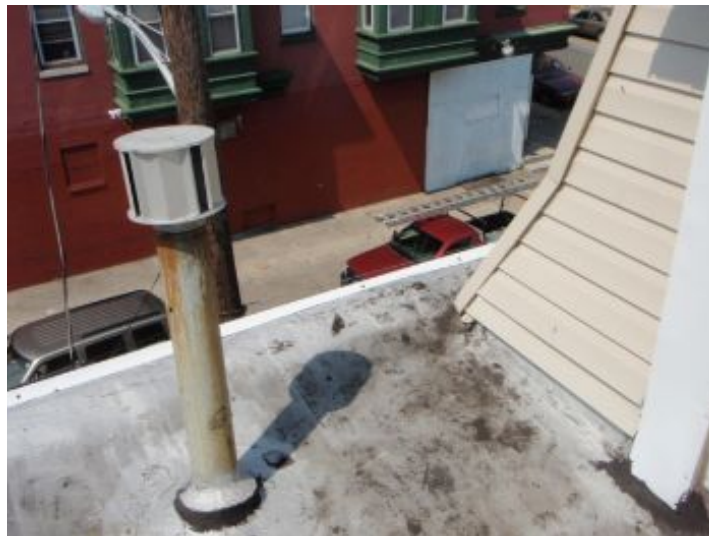
- The B-vent for the 2nd floor furnace appears too close to the exterior wall and should extend at least 2' above the 3rd story roof to allow for proper draft. A licensed HVAC contractor is recommended to evaluate and correct 2nd floor furnace B-vent.

B-Vent for 2nd Floor Furnace is Too Close to the Exterior Wall

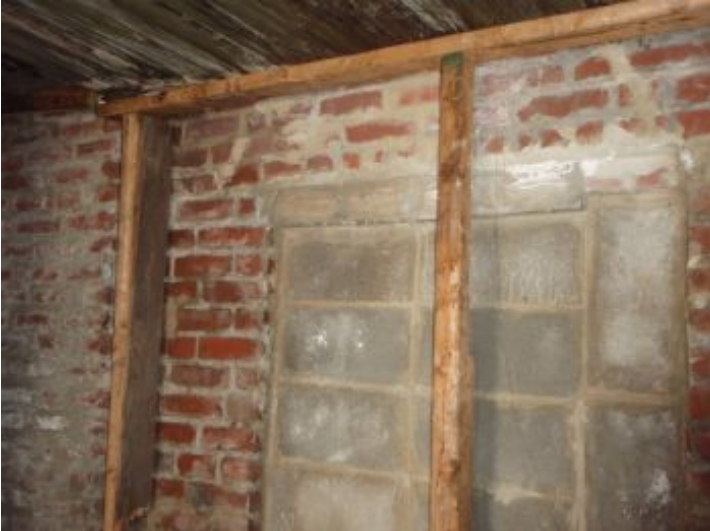
- The garage roof sheathing is rotting in several locations and the roof appears to be leaking at the northeast corner of the garage. A licensed general contractor is recommended to fully evaluate the entire garage.

Rotting Roof Sheathing and Rafters

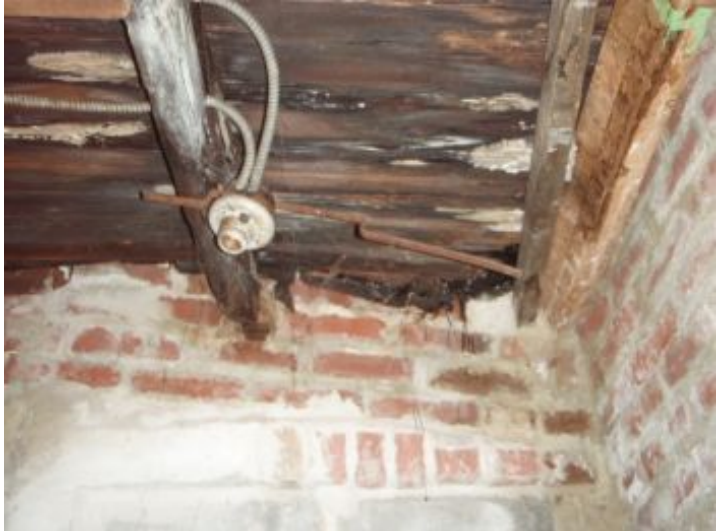
Rotting Roof Sheathing

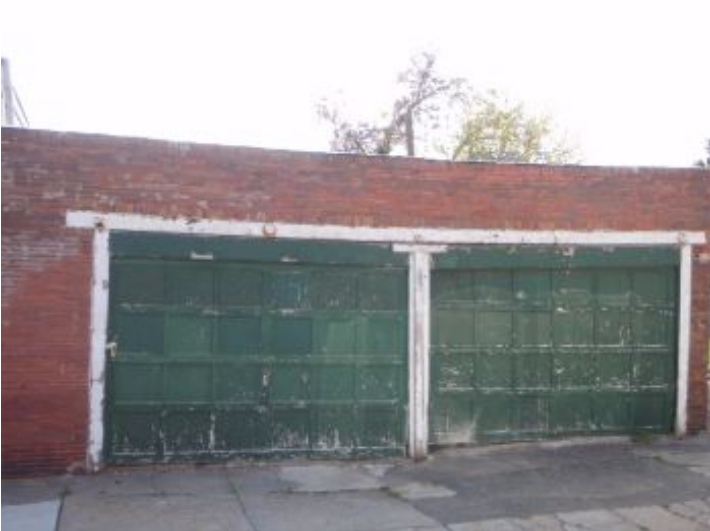
- The garage does not appear to be structurally sound. The brick exterior walls show signs of major movement and are leaning in multiple directions. The garage door header shows signs of major sag. A licensed engineer is recommended to fully evaluate garage structure and a licensed general contractor is recommended to rebuild garage.

Sagging Door Lintel/Header

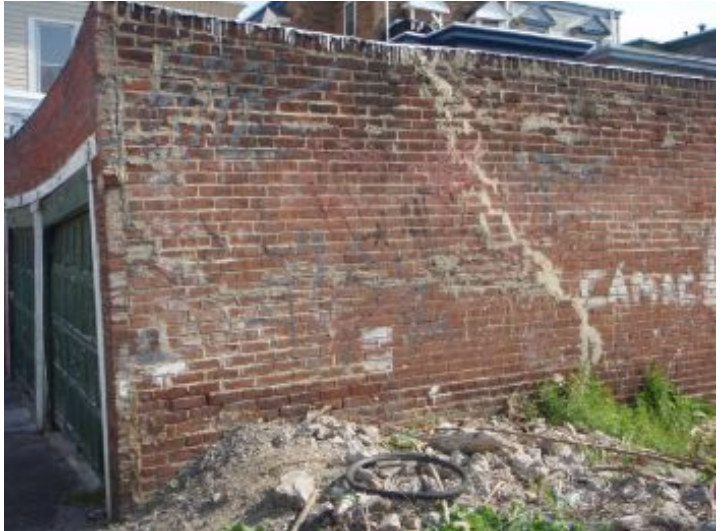
Signs of Major Structural Movement in the Garage Exterior Walls

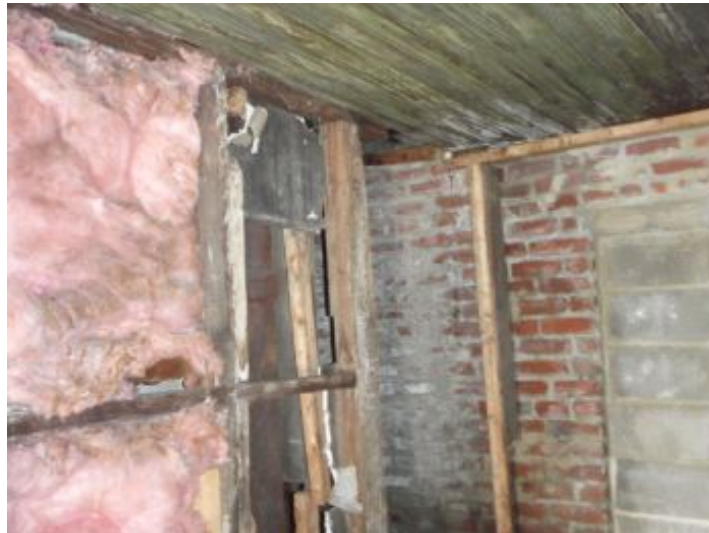
Temporary Supports in Garage

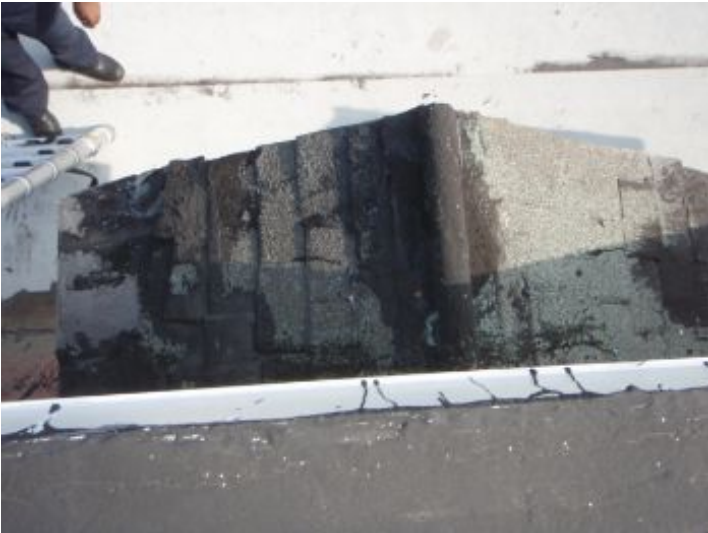
- The roof shingles are deteriorating and appear to be at the end of their expected life above the 3rd story dormer windows. A licensed roofer is recommended to evaluate and replace roof covering on dormer windows.

Damaged Dormer Window Roof

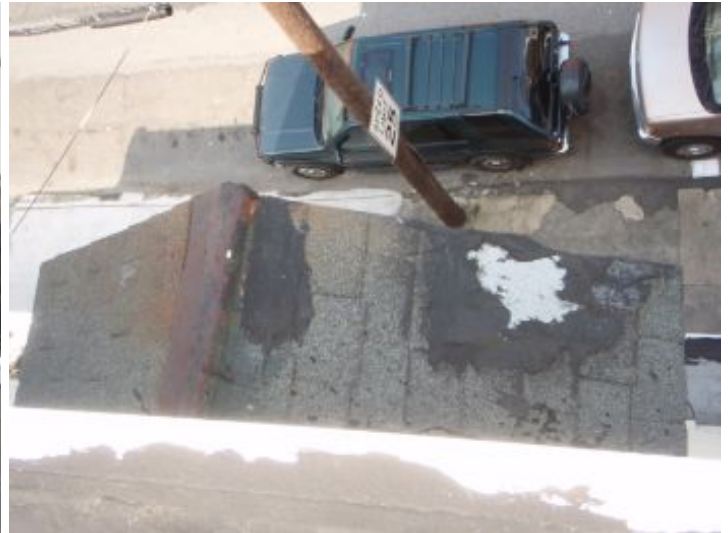
Damaged Dormer Window Roof

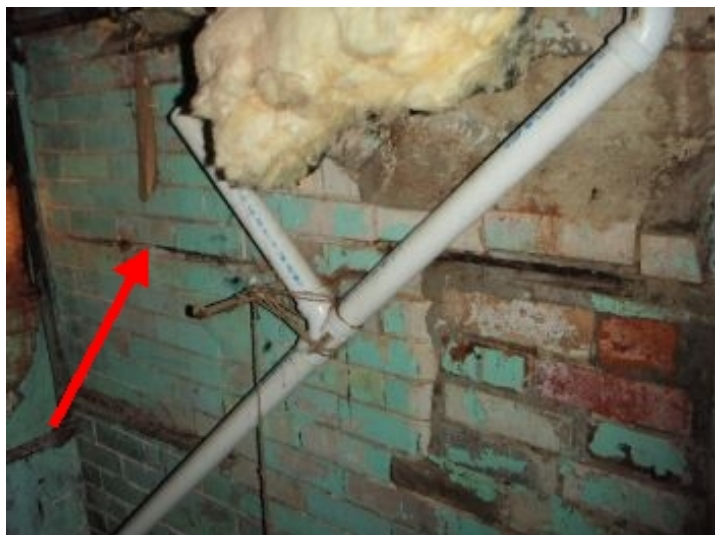
- The parging shows signs of moderate deterioration. Regular maintenance and repairs is recommended.
- Signs of moderate moisture seepage noted - moisture staining was noted around the perimeter of the foundation wall. A licensed landscaper is recommended to fully evaluate and improve exterior drainage around the property.
- I was unable to fully evaluate the foundation wall because surface finishes in the basement block access to the foundation wall.
- The rear section of the foundation walls were covered with a decorative stone surface - I was unable to determine why.
- Major horizontal cracking and signs of structural movement noted in the foundation wall at the rear of the basement. The brick appears to be bulging and shows signs of significant movement. A licensed structural engineer is recommended to fully evaluate foundation walls.

Horizontal Crack Noted in Rear Foundation Wall

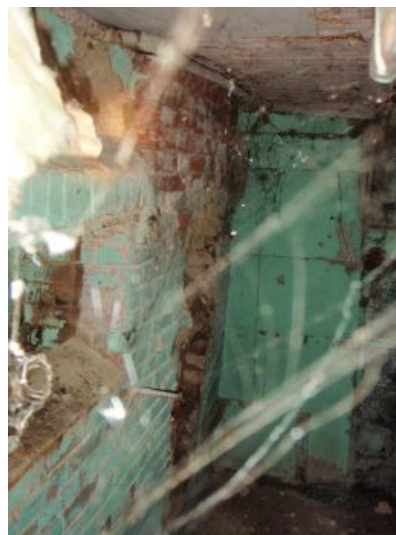
Foundation Wall Appears to be Bulging

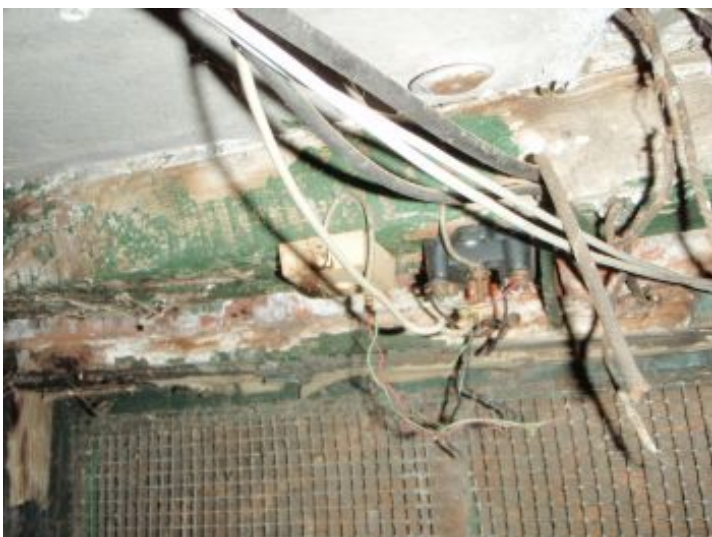
- Signs of moderate moisture staining noted on framing. A licensed carpenter is recommended to fully evaluate and replace moisture damaged framing.
- Framing is moisture damaged and rotting in a few locations in the basement. Recommend periodic inspections and repairs when necessary.
- Bridging is missing or damaged in various locations in the basement.
- The framing was not visible in the basement because finished walls blocked access.
- Two window headers in the middle section of the basement where the water heaters are located and one header at the middle window on the east facing wall in the rear section of the basement are sagging and do not appear sound. A licensed carpenter is recommended to evaluate the framing in the basement and replace damaged window headers.

Rotting Window Header

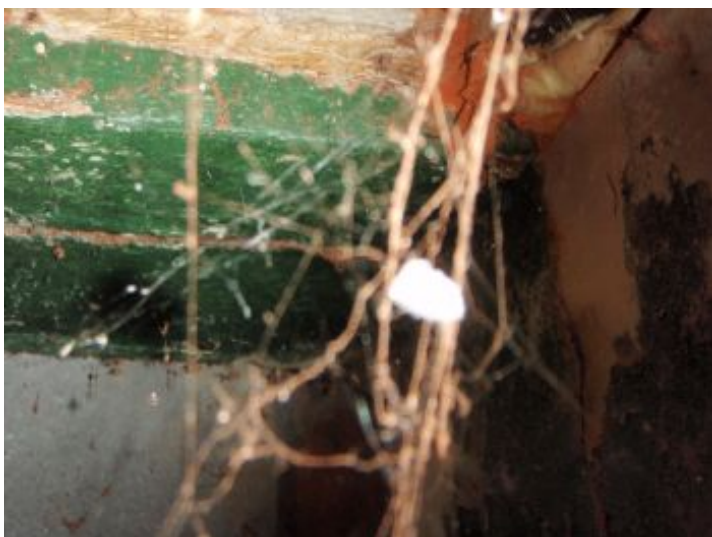
Rotting Window Header

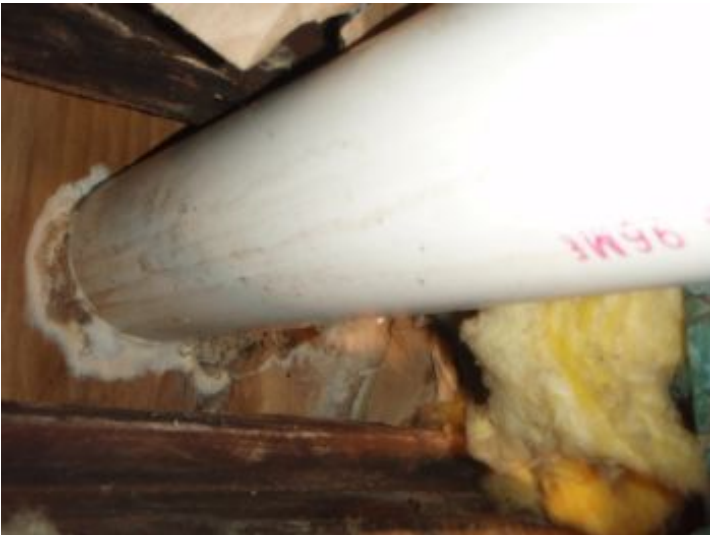
- The subflooring is rotting and moisture damaged at the northwest corner of the basement, under the 1st floor front bathroom and under the 1st floor rear bathroom. A licensed carpenter is recommended to fully evaluate and repair/replace damaged subfloor.

Rotting Subfloor Under Bathroom

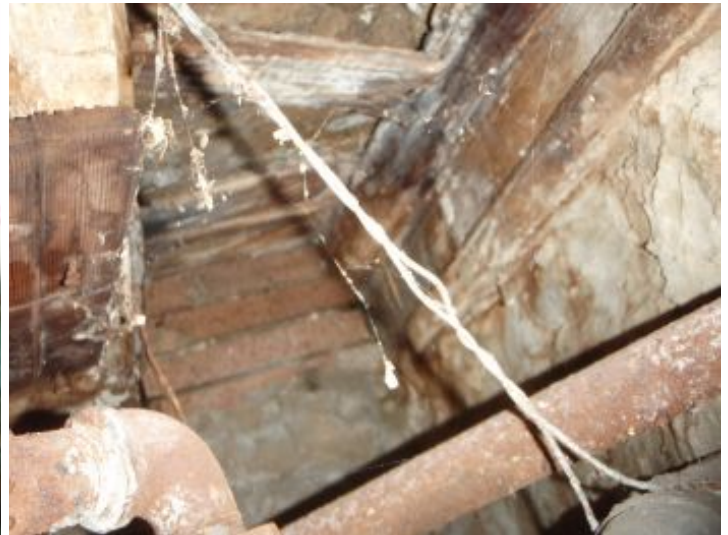
Rotting Flooring at Northwest Corner of Basement

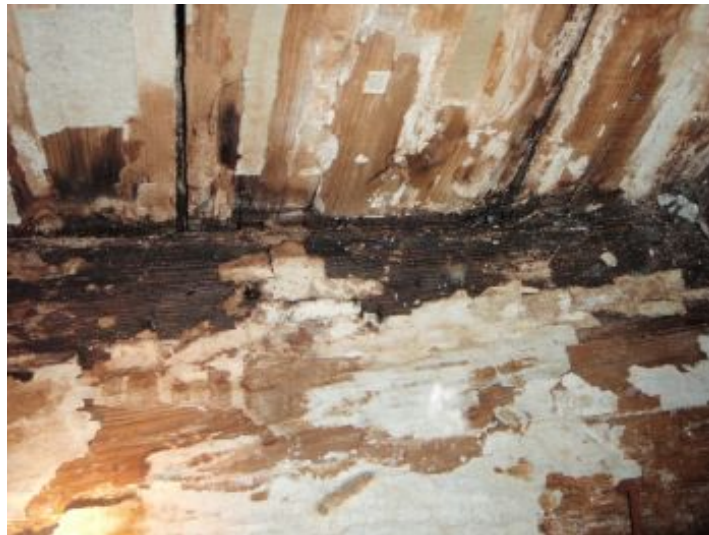
Rotting Flooring Under Bathroom

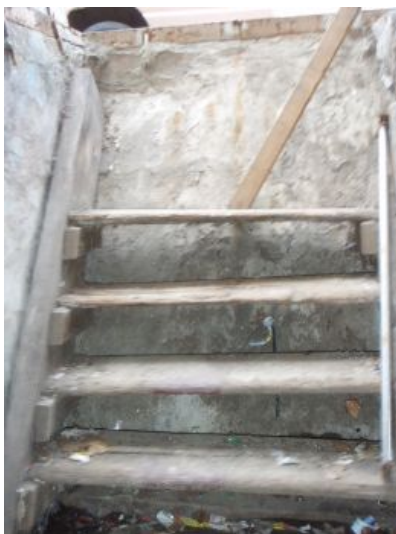
- Handrails missing on exterior stairs.
- The basement door opening was sealed at the east side of the building, but the old stairway opening is filled with debris and trash. A licensed carpenter is recommended to seal the opening to the stairwell to prevent water entry and remove all stored items.
- **The stairs to the basement are damaged, uneven and unsafe. A licensed carpenter is recommended to replace stairs to basement.**

Damaged Stairs to Basement

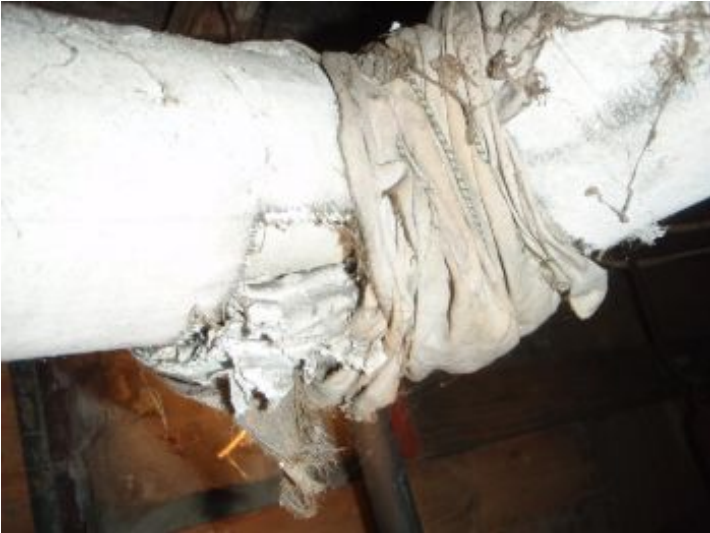
- Recommend removing all stored items, trash and debris from the basement.
- **Possible mold staining noted on the sheetrock in the middle section of the basement. The old heater distribution piping is wrapped in damaged insulation that may contain asbestos. A licensed environmental testing company is recommended to test basement walls for mold and test insulation for asbestos and a licensed removal company is recommended to properly dispose of all moisture damaged and moldy building materials and any asbestos containing materials. A licensed contractor is recommended to identify and eliminate moisture sources into basement.**

Possible Asbestos Containing Insulation in Basement

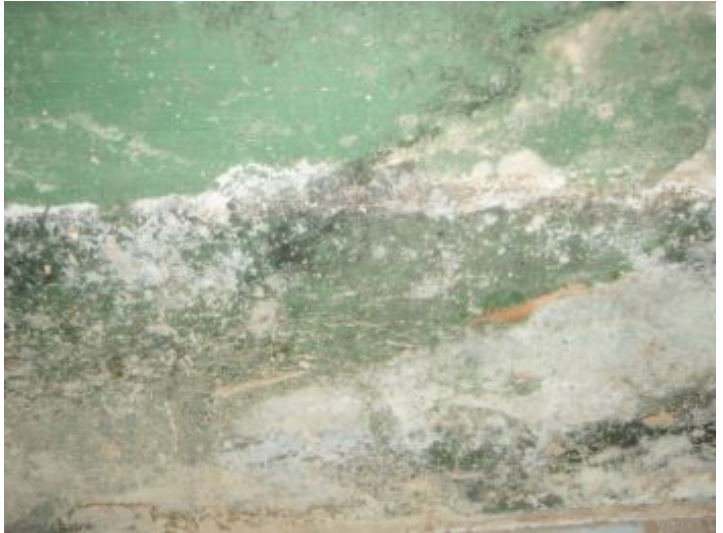
Possible Mold Staining on Finished Wall in Basement

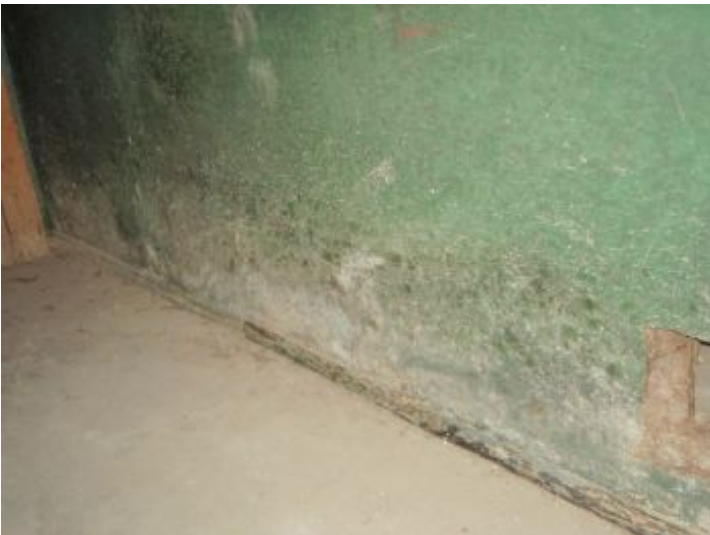
Possible Mold Staining on Finished Wall in Basement

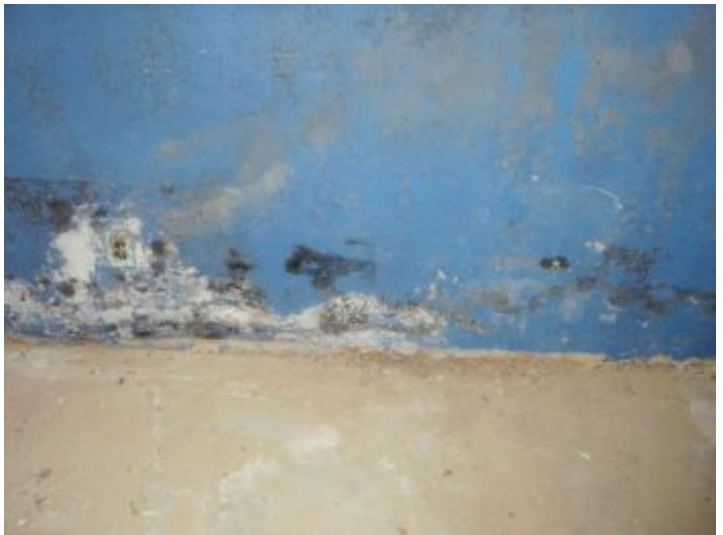
Possible Mold Staining on Finished Wall in Basement

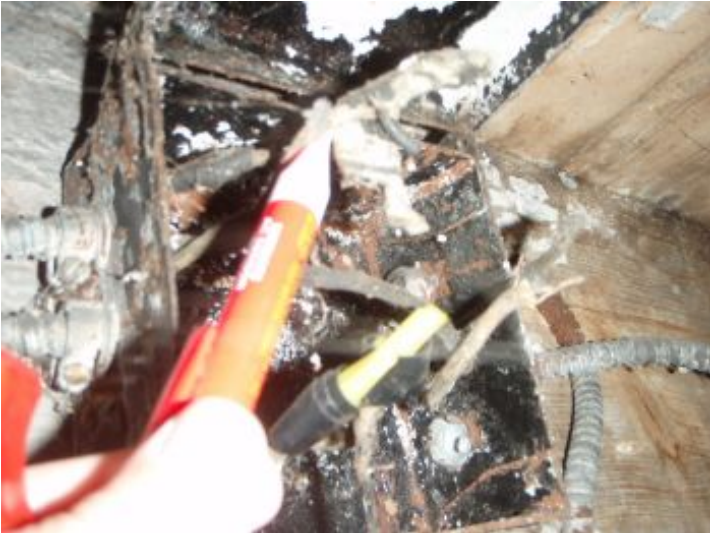
- Exposed electrical wiring observed throughout the basement including exposed splices, open junction boxes and loose and hanging wires. This is a safety concern and should be corrected. A licensed electrician is recommended to fully evaluate and correct defective wiring in the basement.

Exposed Wires Noted in Basement

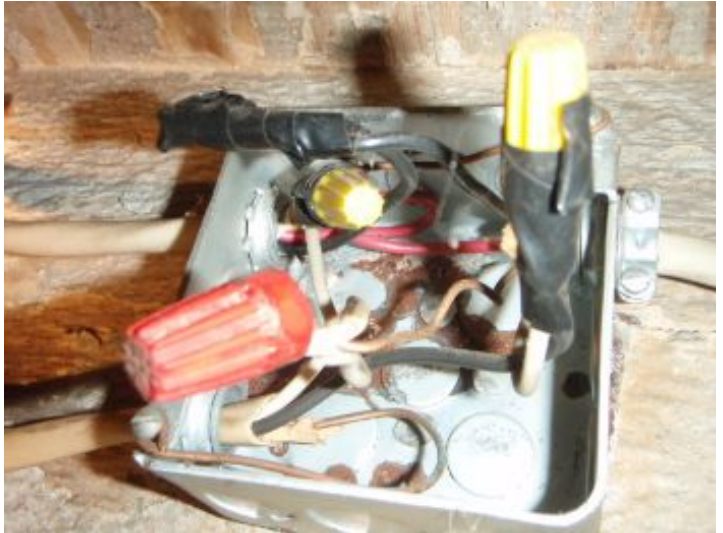
Ground and Neutral Wires Connected at Junction Box in Basement

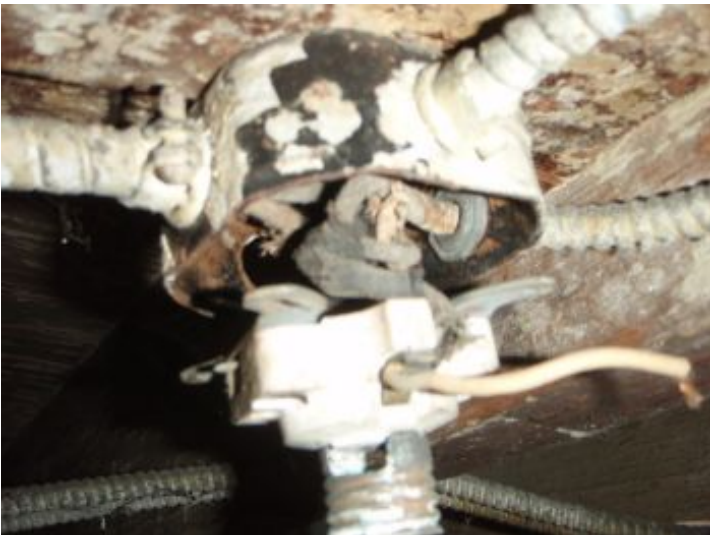
Exposed Wires at Light Fixture in Basement

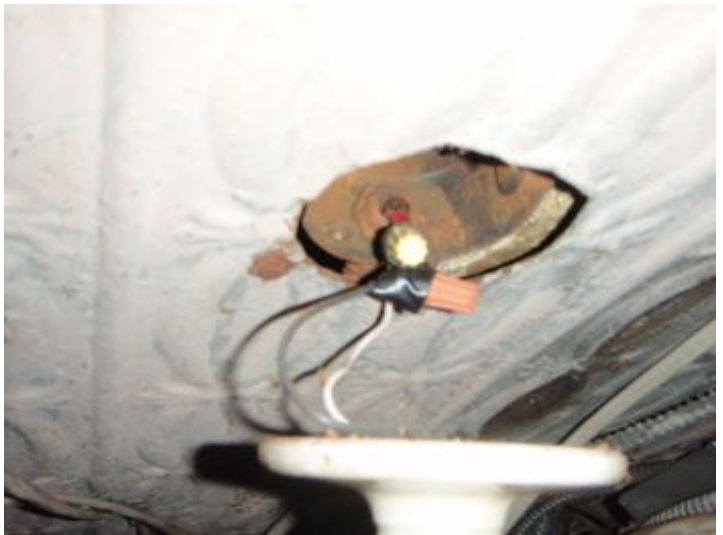
Exposed Wires at Light Fixture in Basement

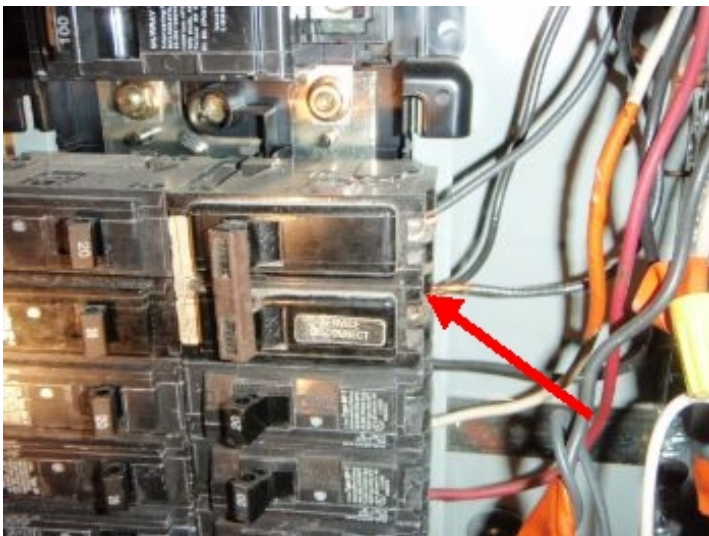
- Defects noted in the 1st floor front main panel: Overfused circuits, double taps, missing branch ties for 240V circuits, unprotected openings and panel does not appear to be grounded.
- Defects noted in the garage main panel: Panel does not appear to be bonded and openings noted in panel.
- Defects noted at 1st floor rear main panel: Overfused breakers, cloth sheathed wiring is damaged and exposed and panel does not appear to be bonded.
- Defects noted in 2nd floor main panel: Overfused breakers, double tapped breakers and does not appear to be bonded.
- Defects noted in 3rd floor main panel: Overfused breakers, double tapped breakers and panel does not appear to be bonded.
- A licensed electrician is recommended to fully evaluate and correct all defects noted in main panels.

Overfused and Double Tapped Breaker at 1st Floor Front Panel

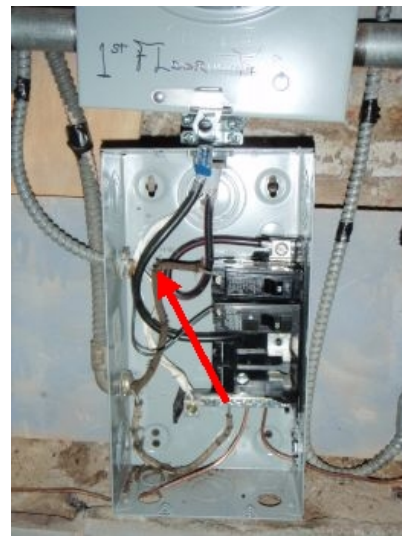
Damaged Sheathing Noted on Wire in 1st Floor Rear Panel

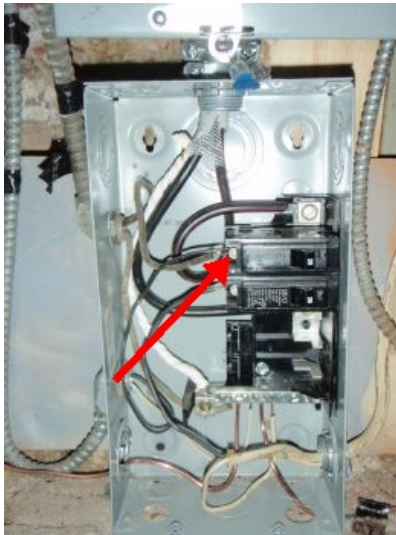
Overfused and Double Tapped Breaker in 2nd Floor Panel

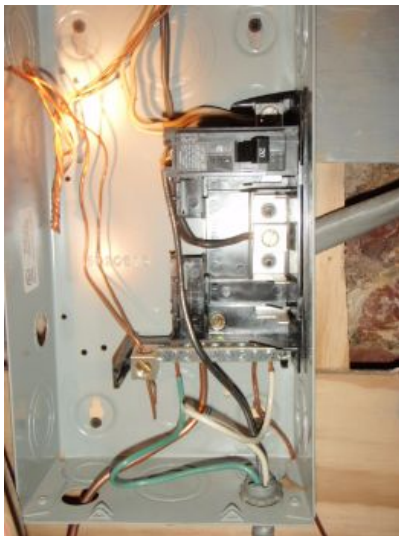
- The two subpanels on the front east facing foundation wall have exposed wires and the fuse panel has an overfused circuit. A licensed electrician is recommended to disconnect these subpanels.
- Subpanel located between the first floor front main panel and the garage main panel does not appear to have been properly wired and should be evaluated and corrected by a licensed electrician.
- The fire alarm subpanel appears to have an overfused breaker.
- A licensed electrician is recommended to fully evaluate and correct defects noted in the subpanels.

Improperly Wired Subpanel

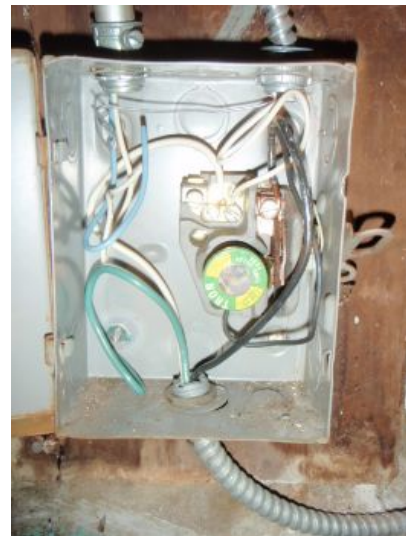
Overfused Circuit at Fire Alarm Panel

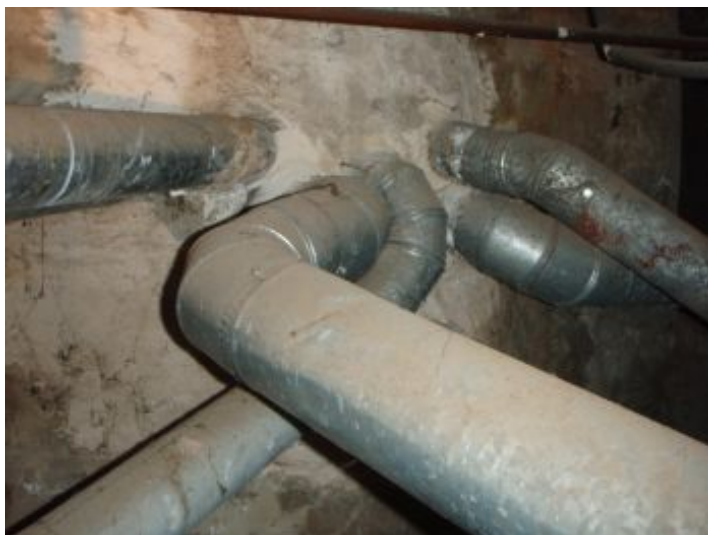
- The chimney flue liner is deteriorating and 6 gas appliances vent to the same flue. This is not a safe condition and should be completely evaluated by a licensed plumber, HVAC contractor or chimney sweep. Generally accepted practice allows 2 (sometimes more than 2 in special circumstances) gas burning appliances on the same floor to vent to the same chimney flue.

Six Gas Appliances Vent to the Same Chimney Flue

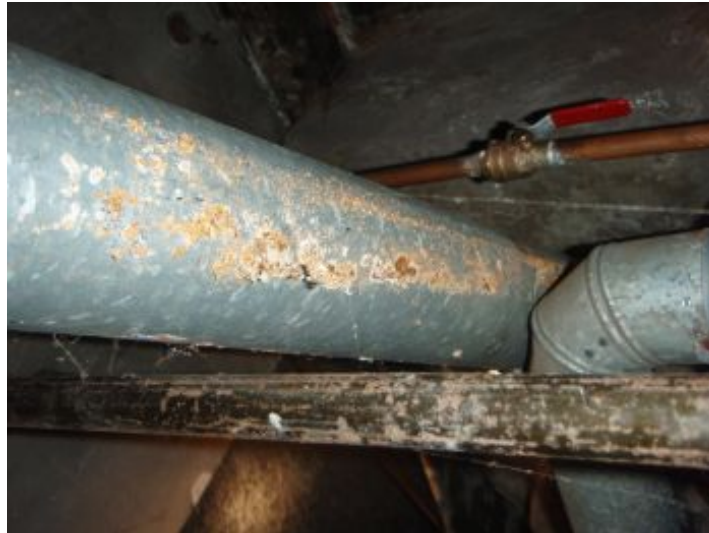
- See comments in the 1st floor front heating section of the report.
- The vent pipe appears to be too long and there is corrosion noted on the underside of the vent pipe - this is an indication that the system is not drafting properly. A licensed HVAC contractor is recommended to fully evaluate and correct drafting issues at furnace.

Corrosion Noted on Underside of Vent Pipe Indicating Possible Drafting Problems

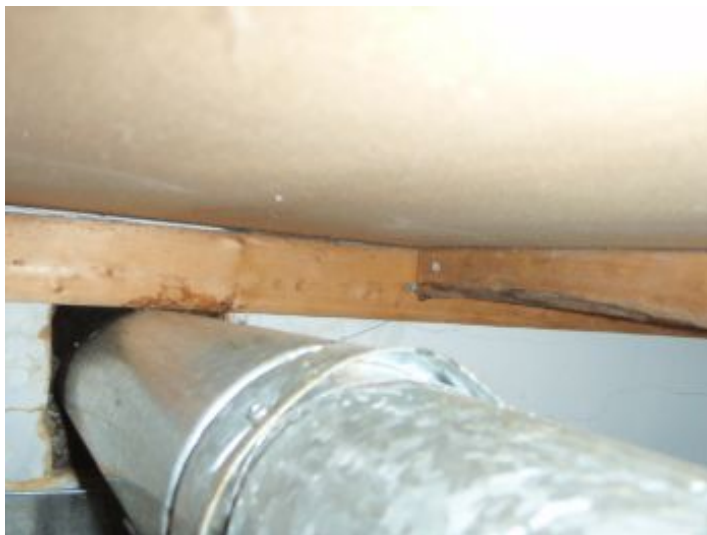
- Vent was not fully visible.
- The B-vent is too close to combustibles in the closet (there should be a minimum of 1" clearance between the framing and vent pipe). A licensed HVAC contractor is recommended to correct vent pipe.

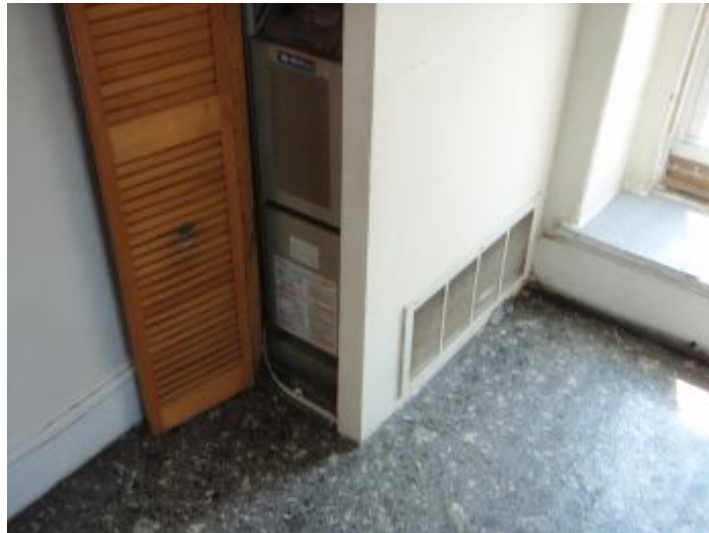
- Combustion air and return air are too close and can mix. This can be very dangerous and should be evaluated and corrected by a licensed HVAC contractor.

Combustion and Return Air Sources are too Close and Can Mix

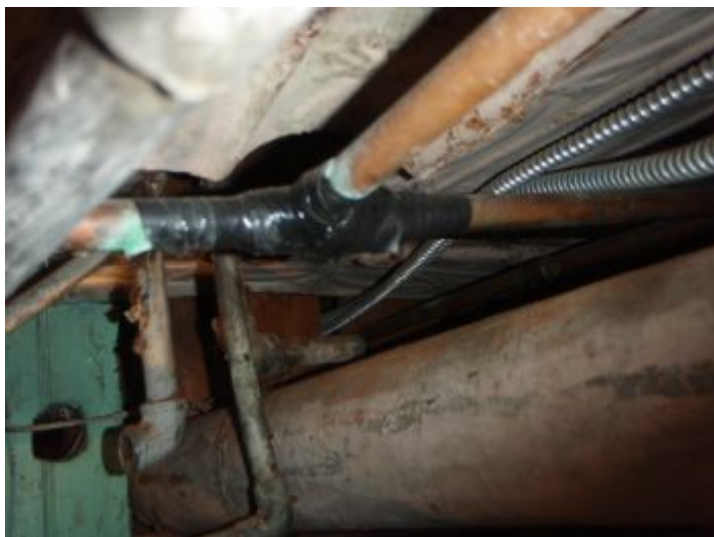
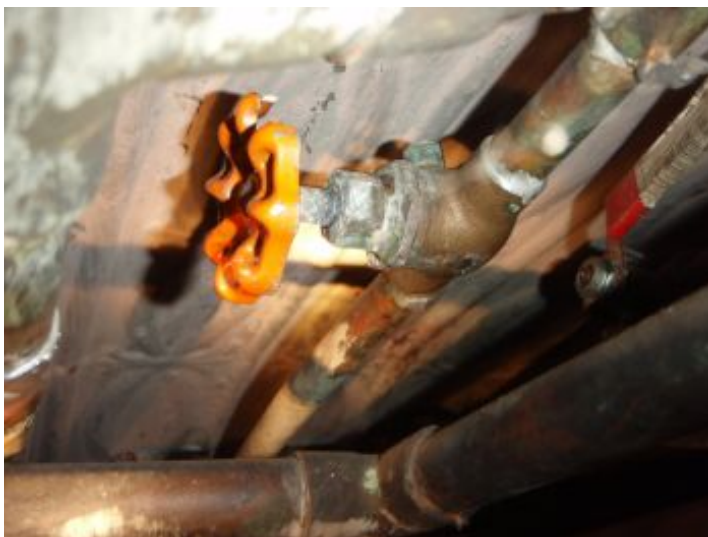
- Major corrosion noted in the basement.
- Type M copper was used in multiple locations throughout the house. Type M copper is thin walled and can prematurely deteriorate. A licensed plumber is recommended to fully evaluate and replace any defective water supply lines.
- Leaks noted in the supply piping near the rear furnace in the basement. A licensed plumber is recommended to fully evaluate water supply lines and repair any leaks.

Leak at Supply Line in Basement

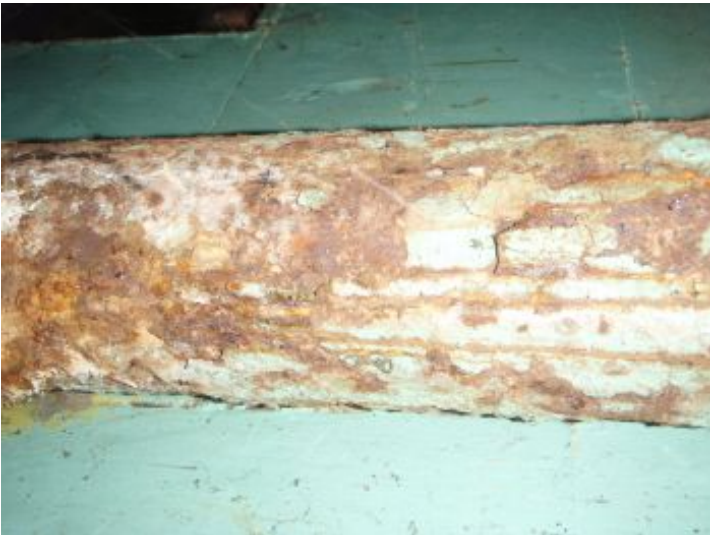
- Note - City sewer service, septic systems and all underground pipes are not part of this inspection. Future drainage performance is also not determined. Be advised that some "ABS" plastic piping systems have experienced documented problems. Contact the manufacturer or plumbing expert for further information and evaluation.
- Major corrosion noted in the cast iron waste pipe. Cast iron appears to be cracked in multiple locations in the basement. Signs of amateur workmanship noted throughout the basement. Multiple open waste pipes, improperly sloped drainlines, improperly installed cleanouts that can easily back system up, missing shear rings and improperly supported drain lines noted. There is a leak at the drainpiping in the rear section of the basement. A licensed plumber is recommended to fully evaluate and correct all defects noted in the waste lines.

Major Corrosion Noted at Cast Waste Pipe

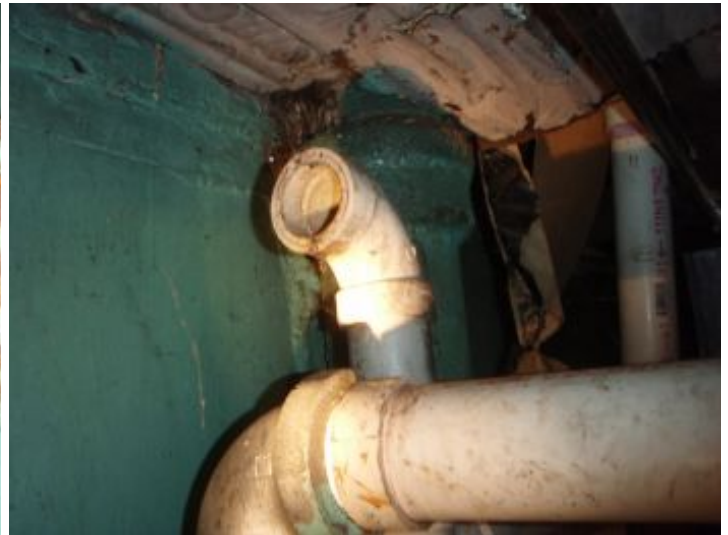
Open Waste Pipe in Basement

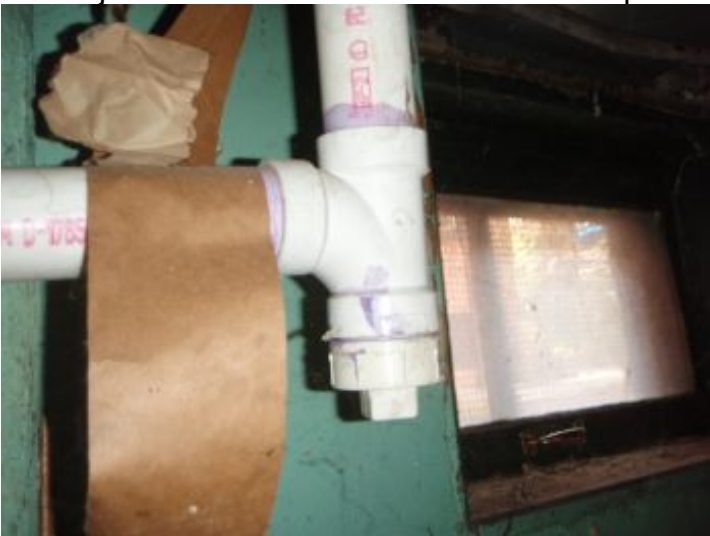
Improperly Installed Cleanout is Highly Vulnerable to Clogs

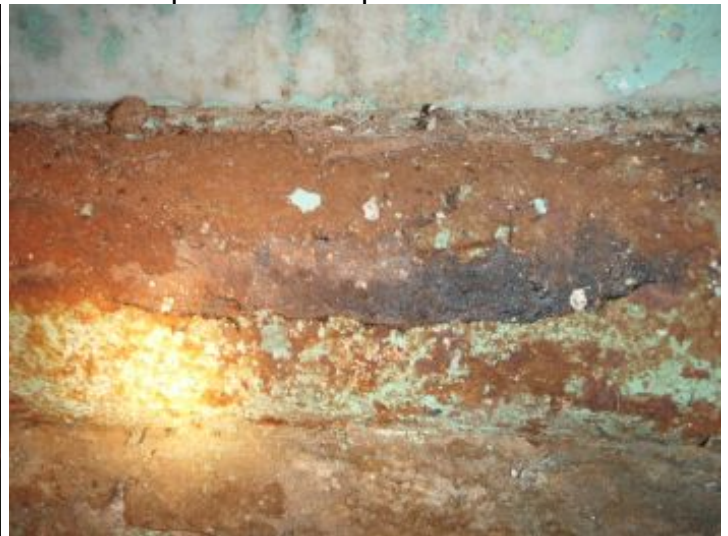
Cracked Cast Iron Waste Pipe

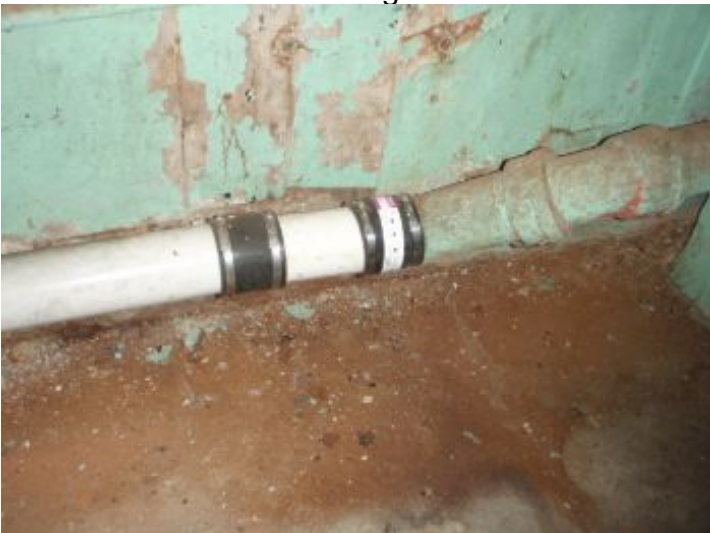
Missing Shear Rings/Waste Pipe Not Properly Supported

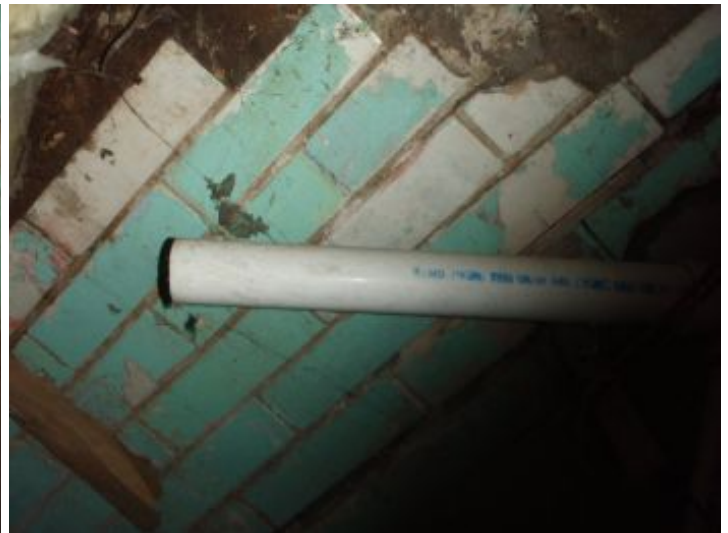
Open Waste Pipe in Basement

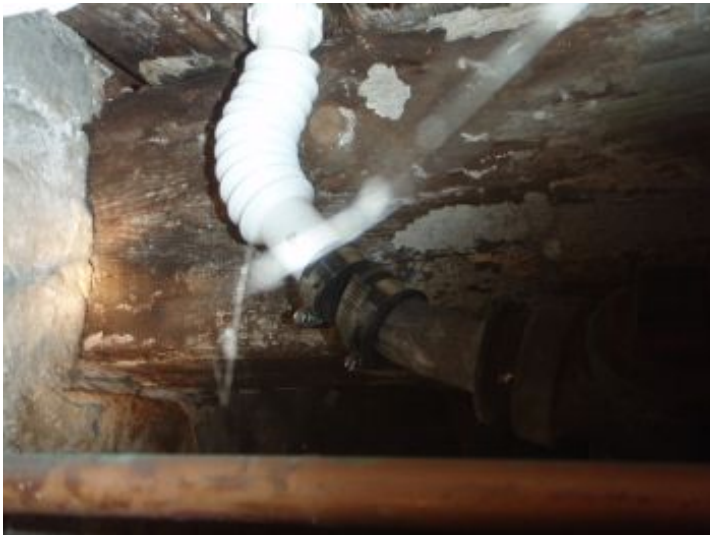
Improper Drainpiping in the Basement

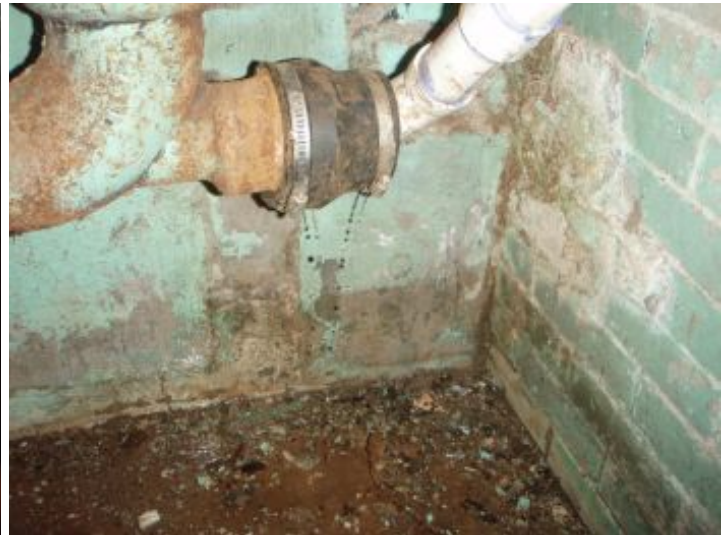
Leak at Drain in Rear Section of Basement

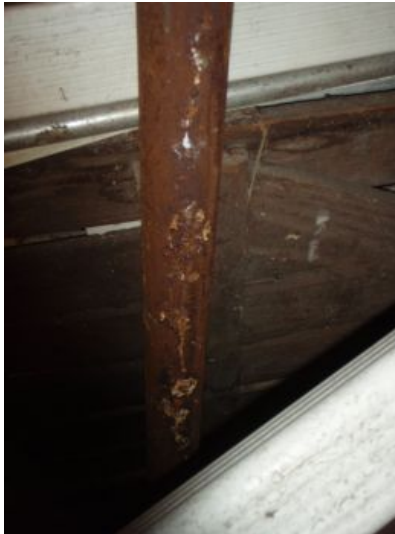
Cracked Cast Iron Waste Pipe in Basement

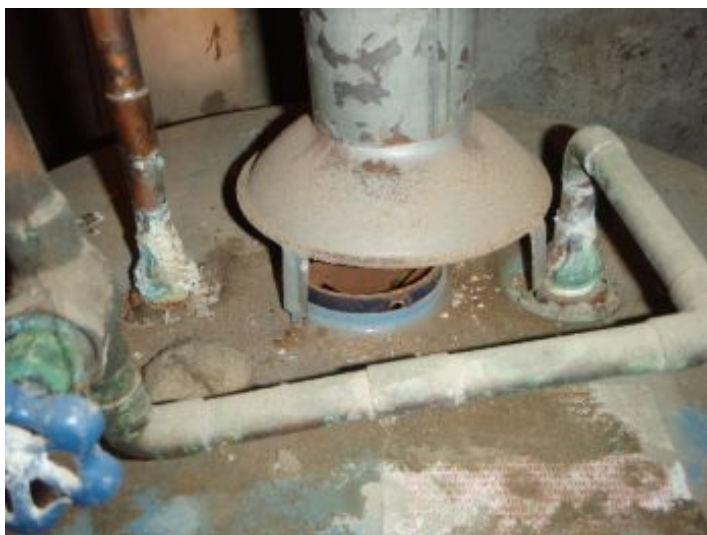
- See comments in 1st floor front heating section of report.
- Vent hood is not properly attached at the top of the unit - system appears to backdraft. A licensed plumber is recommended to fully evaluate system.

Draft Hood Improperly Installed

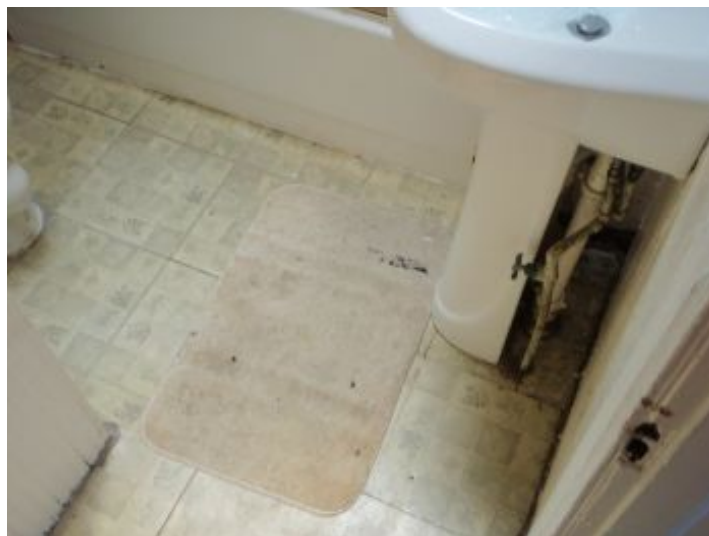
- **Flooring show signs of major wear and deterioration. The subflooring is soft and the floor tiles are moisture stained and lifting. A licensed contractor is recommended to fully evaluate and replace floor coverings and subflooring if necessary.**

Moisture Damaged Flooring and Subflooring

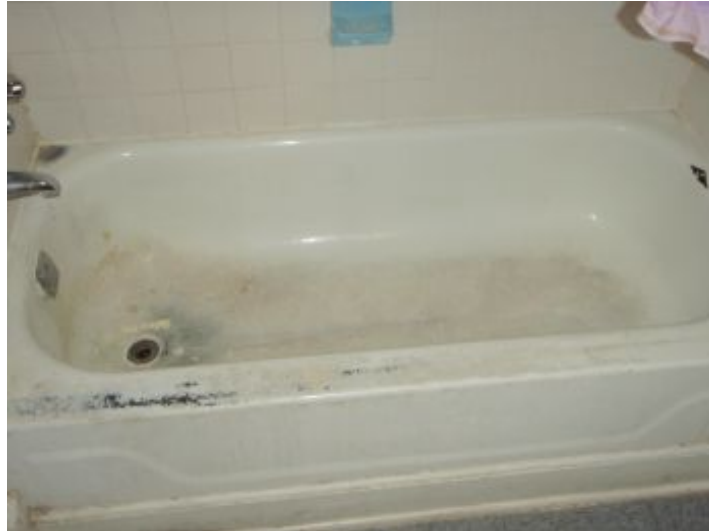
- Stopper is missing.
- Tub access was painted shut and was not removed during the inspection.
- Major stains and damaged porcelain noted at the tub. A licensed plumber is recommended to replace or refinish damaged tub.

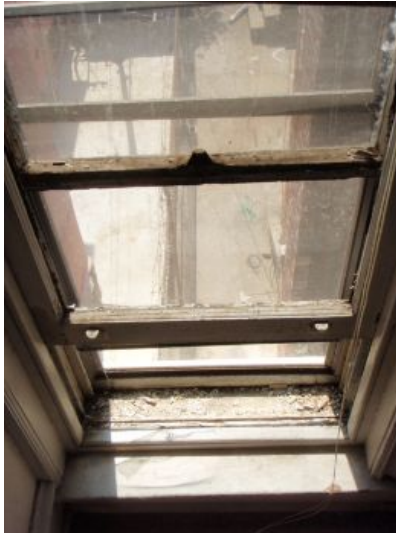
- Lockable window bars installed in various locations - this is a potential fire egress concern and should be corrected.
- Damaged screens or missing screens observed.
- The window glazing is deteriorating and the paint is chipping on the surface of the windowsill and sash. The paint may contain lead. A licensed contractor is recommended to take the necessary precautions if paint contains lead and replace window or scrape and re-paint window.
- Deterioration of wooden frames noted. Recommend budgeting for replacement in the near future.
- Windowpane missing and window rotted through at the stairway to the third floor. A licensed carpenter is recommended to evaluate and replace the damaged windows.

Broken Window

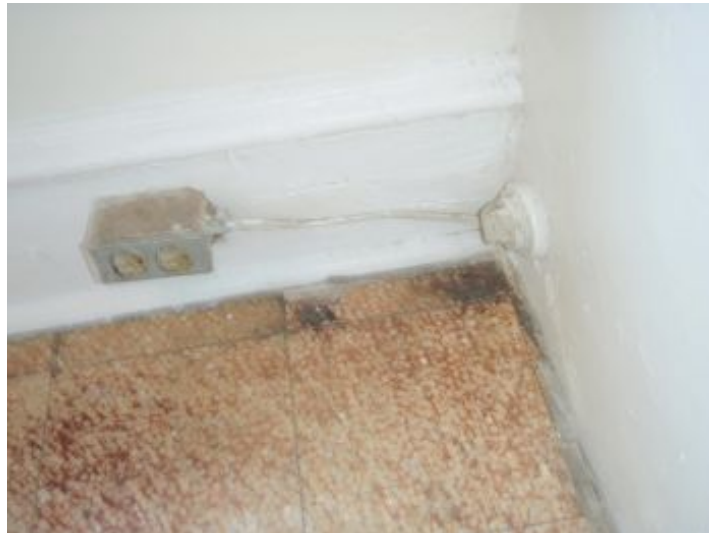
- Ungrounded 3-prong outlets noted.
- Ungrounded, 2-prong receptacles located in various locations. Although this condition may have been commonly considered safe or acceptable at the time the home was originally constructed, as general knowledge of safe building practices has improved with the passage of time, building standards have changed to reflect current understanding. Consider updating the existing condition to meet the generally accepted current standards.
- **Exposed wire run on the wall in the kitchen. A licensed electrician is recommended to correct improperly wired receptacles.**

Exposed Wire Run in Kitchen

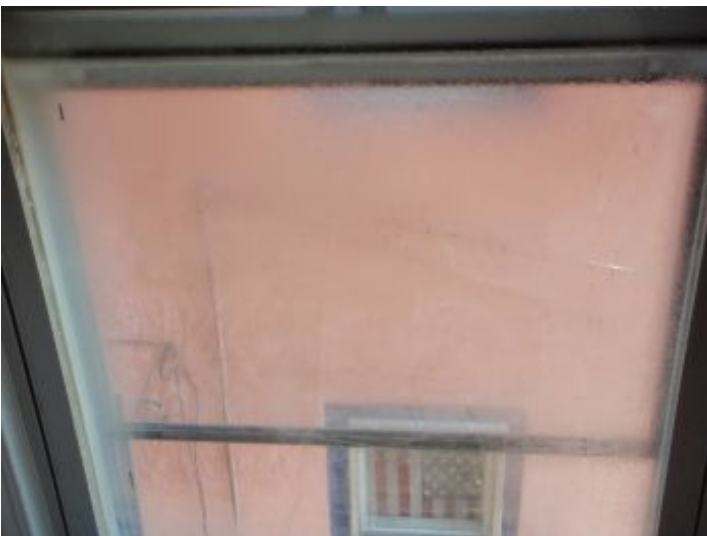
- Deterioration of wooden frames noted. Recommend budgeting for replacement in the near future.
- Damaged screens or missing screens observed.
- The window glazing is deteriorating and the paint is chipping on the surface of the windowsill and sash. The paint may contain lead. A licensed contractor is recommended to take the necessary precautions if paint contains lead and replace window or scrape and re-paint window.
- Window sealed in kitchen. Failed thermoseal noted at the middle bedroom window. One window is original and is deteriorating. One of the windowpanes is missing at the northwest room.

Failed Thermoseal at Window
