ARTI Home Inspections, LLC
Property Inspection Report

1000 Anywhere Rd., Anywhere PA, 19000
Inspection prepared for: John Doe
Inspection Date: 4/15/2010 Time: 10am - 2:30pm
Weather: Sunny, 70 degrees

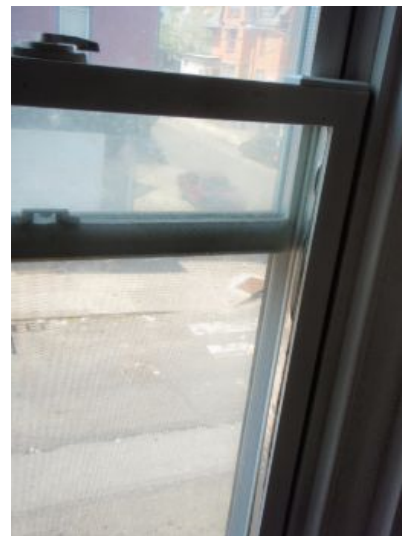
Missing Windowpane at Double Pane Window

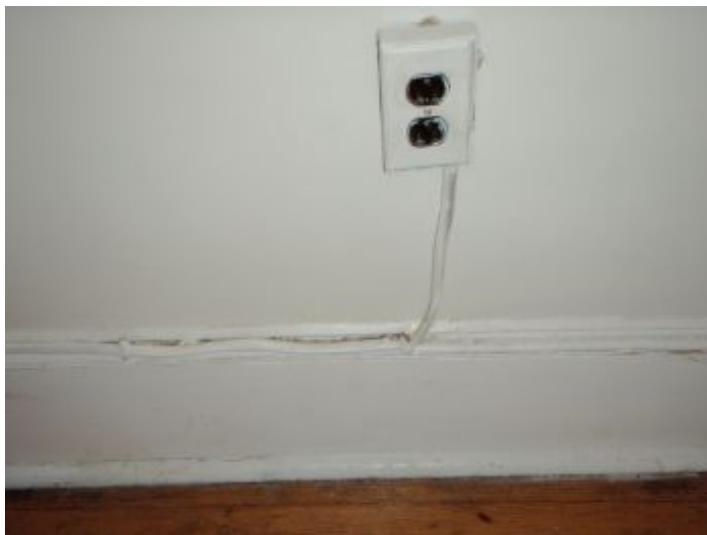
- Ungrounded 3-prong outlets noted.
- Ungrounded, 2-prong receptacles located in various locations. Although this condition may have been commonly considered safe or acceptable at the time the home was originally constructed, as general knowledge of safe building practices has improved with the passage of time, building standards have changed to reflect current understanding. Consider updating the existing condition to meet the generally accepted current standards.
- Exposed wire run on the wall in the bedroom. A licensed electrician is recommended to correct improperly wired receptacles.

Exposed Wiring Run in 3rd Floor Bedroom

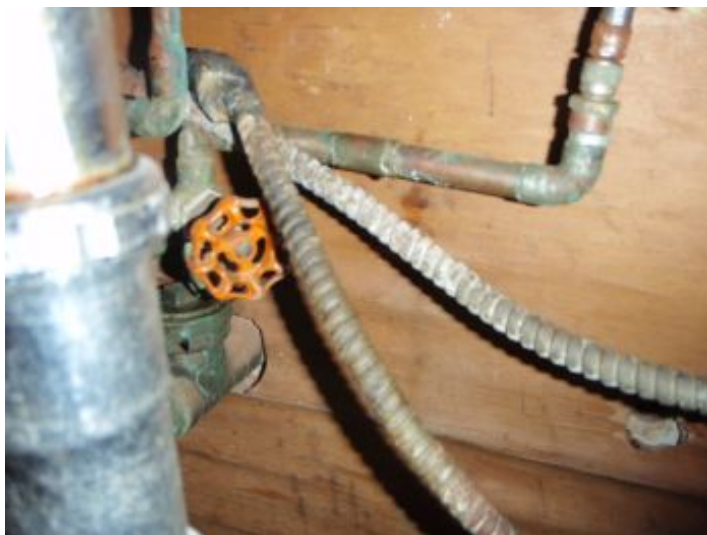
- Sink bowl shows signs of moderate deterioration.
- **Supply line leaks under sink. A licensed plumber is recommended to evaluate and repair leak.**

Leak at Supply Line Under Sink
