ARTI Home Inspections, LLC
Property Inspection Report

1234 Anywhere St., Anywhere PA, 19000
Inspection prepared for: John Doe & Jane Doe
Inspection Date: 4/10/2010 Time: 1-3:30pm
Weather: Sunny, 60 degrees

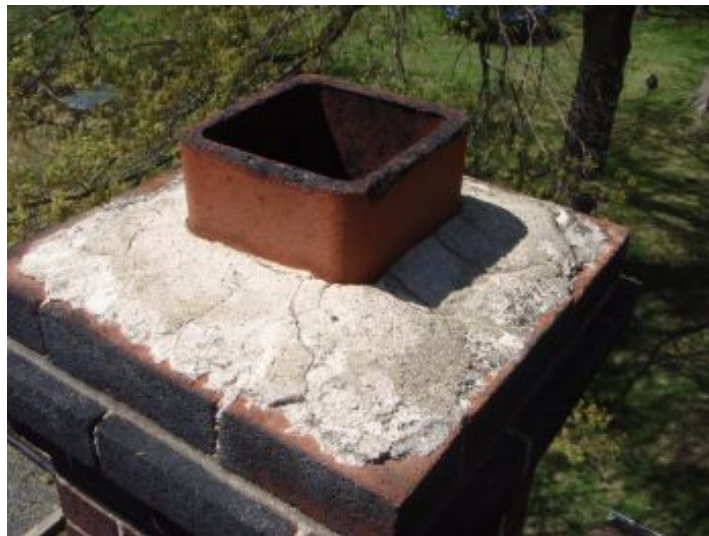
- Raincap missing. A licensed contractor is recommended to add a proper raincap to the chimney flue.
- The chimney crown is cracked. A licensed mason is recommended to repair the crown to prevent future moisture problems.
- **Soot staining noted at the top of the chimney and in the chimney flue. This may be an indication that the heating system is not venting properly. A licensed chimney sweep is recommended to fully evaluate and clean chimney flue. A licensed HVAC contractor is recommended to evaluate and correct any defects in the boiler vent piping, draft and/or burner.**

Soot Staining on the Chimney and Flue

Exterior Areas		
Page 11 Item: 3	Chimney Condition	<ul style="list-style-type: none"> • Soot staining noted at the top of the chimney and in the chimney flue. This may be an indication that the heating system is not venting properly. A licensed chimney sweep is recommended to fully evaluate and clean chimney flue. A licensed HVAC contractor is recommended to evaluate and correct any defects in the boiler vent piping, draft and/or burner.
Garage		
Page 13 Item: 7	120 Volt	<ul style="list-style-type: none"> • The wire sheathing was damaged and improperly repaired at the wire run on the ceiling in the rear section of the garage. A licensed electrician is recommended to replace the damaged wire.
Attic		
Page 16 Item: 5	Exhaust Vent	<ul style="list-style-type: none"> • Exhaust fan duct appears to terminate in attic. Bath fans venting into the attic can increase moisture levels and cause possible mold problems. A licensed roofer is recommended to run bath fan to the exterior of the house.
